NBSIR 73-166

# Fire Endurance Test of an Interdwelling Double Wall Construction of Paper Honeycomb and Gypsum Board

Final Report

As a part of the evaluation of a housing system proposed under Operation BREAKTHROUGH, a fire endurance test was performed at the National Bureau of Standards on a double wall assembly intended as an interdwelling separation for single family attached housing. Each wall of the assembly contained a core of paper honeycomb surfaced on both sides with glass fabric impregnated with polyester resin, and protective layers of gypsum board.

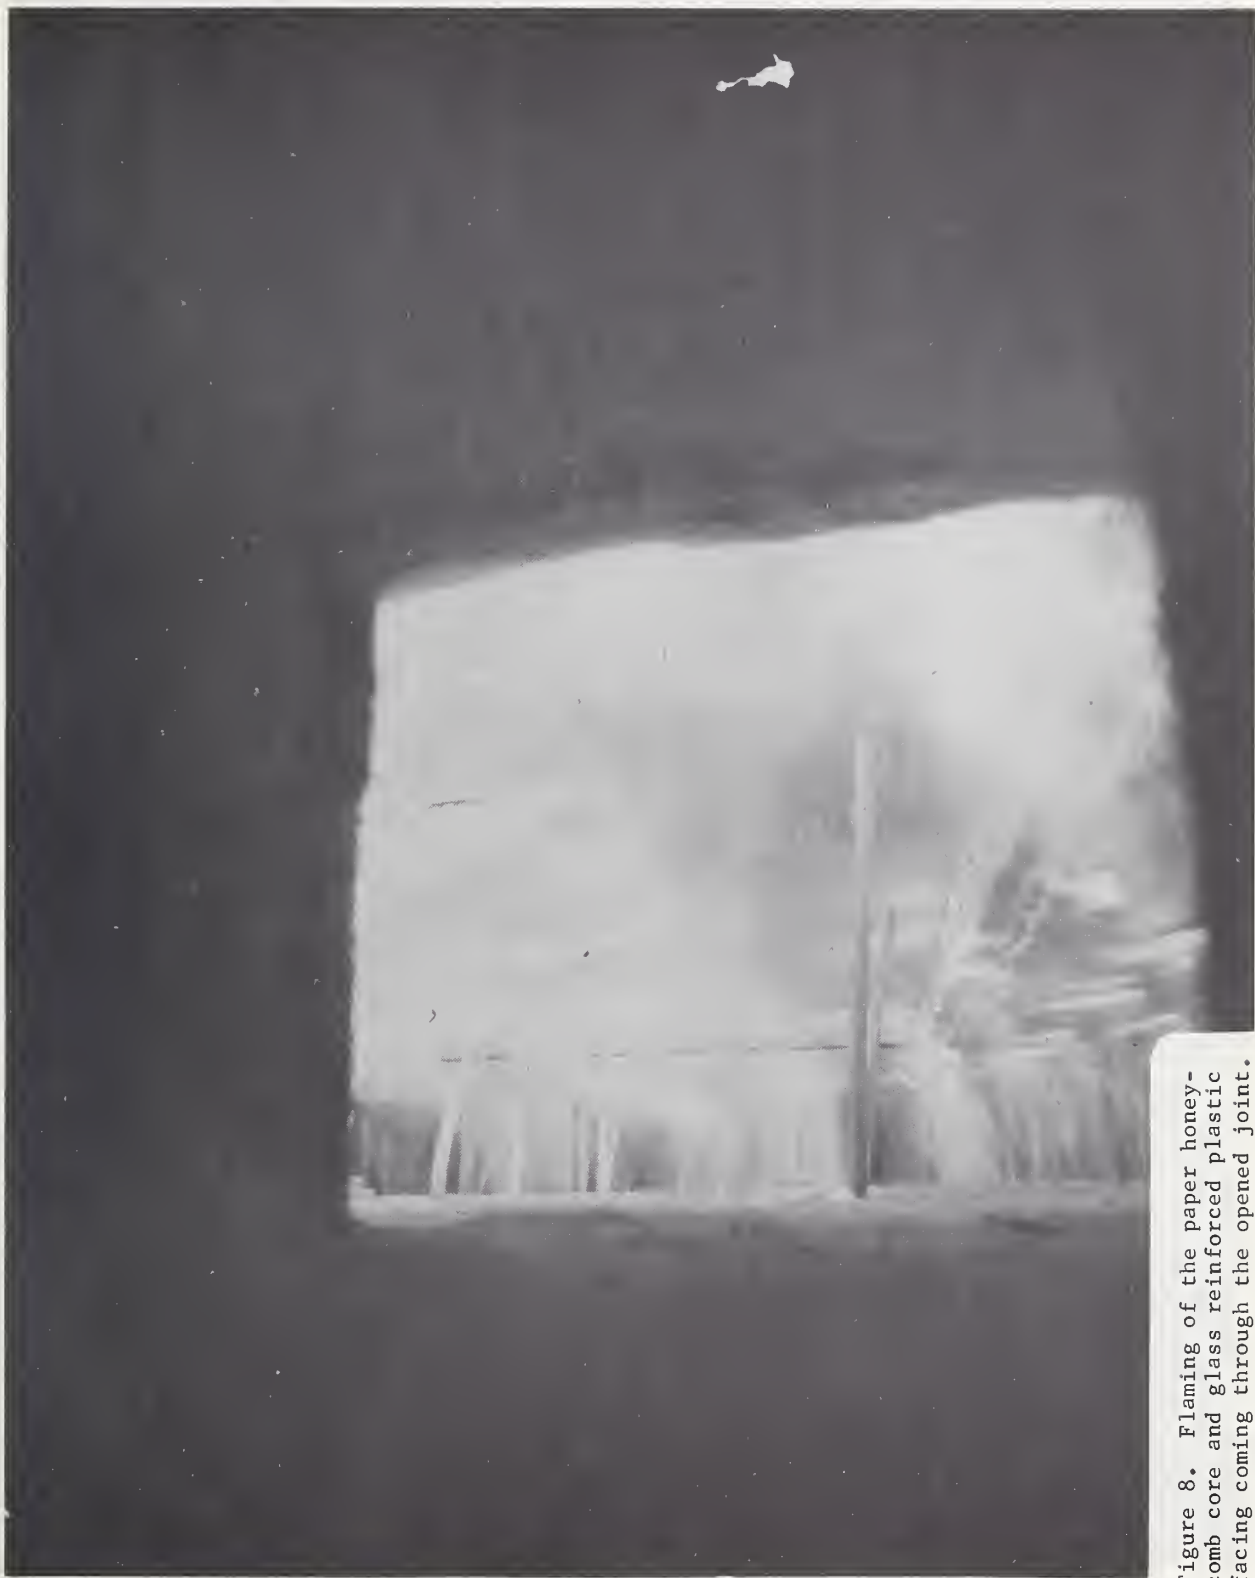
Figure 8. Flaming of the paper honey-comb core and glass reinforced plastic facing coming through the opened joint.  
Time : 22 min.

22:00	First joint from the north end flaming inside the furnace. Figure 7 is a picture taken through the observation window, showing flames from the paper honeycomb core and glass-reinforced plastic skin coming through the opened joint.

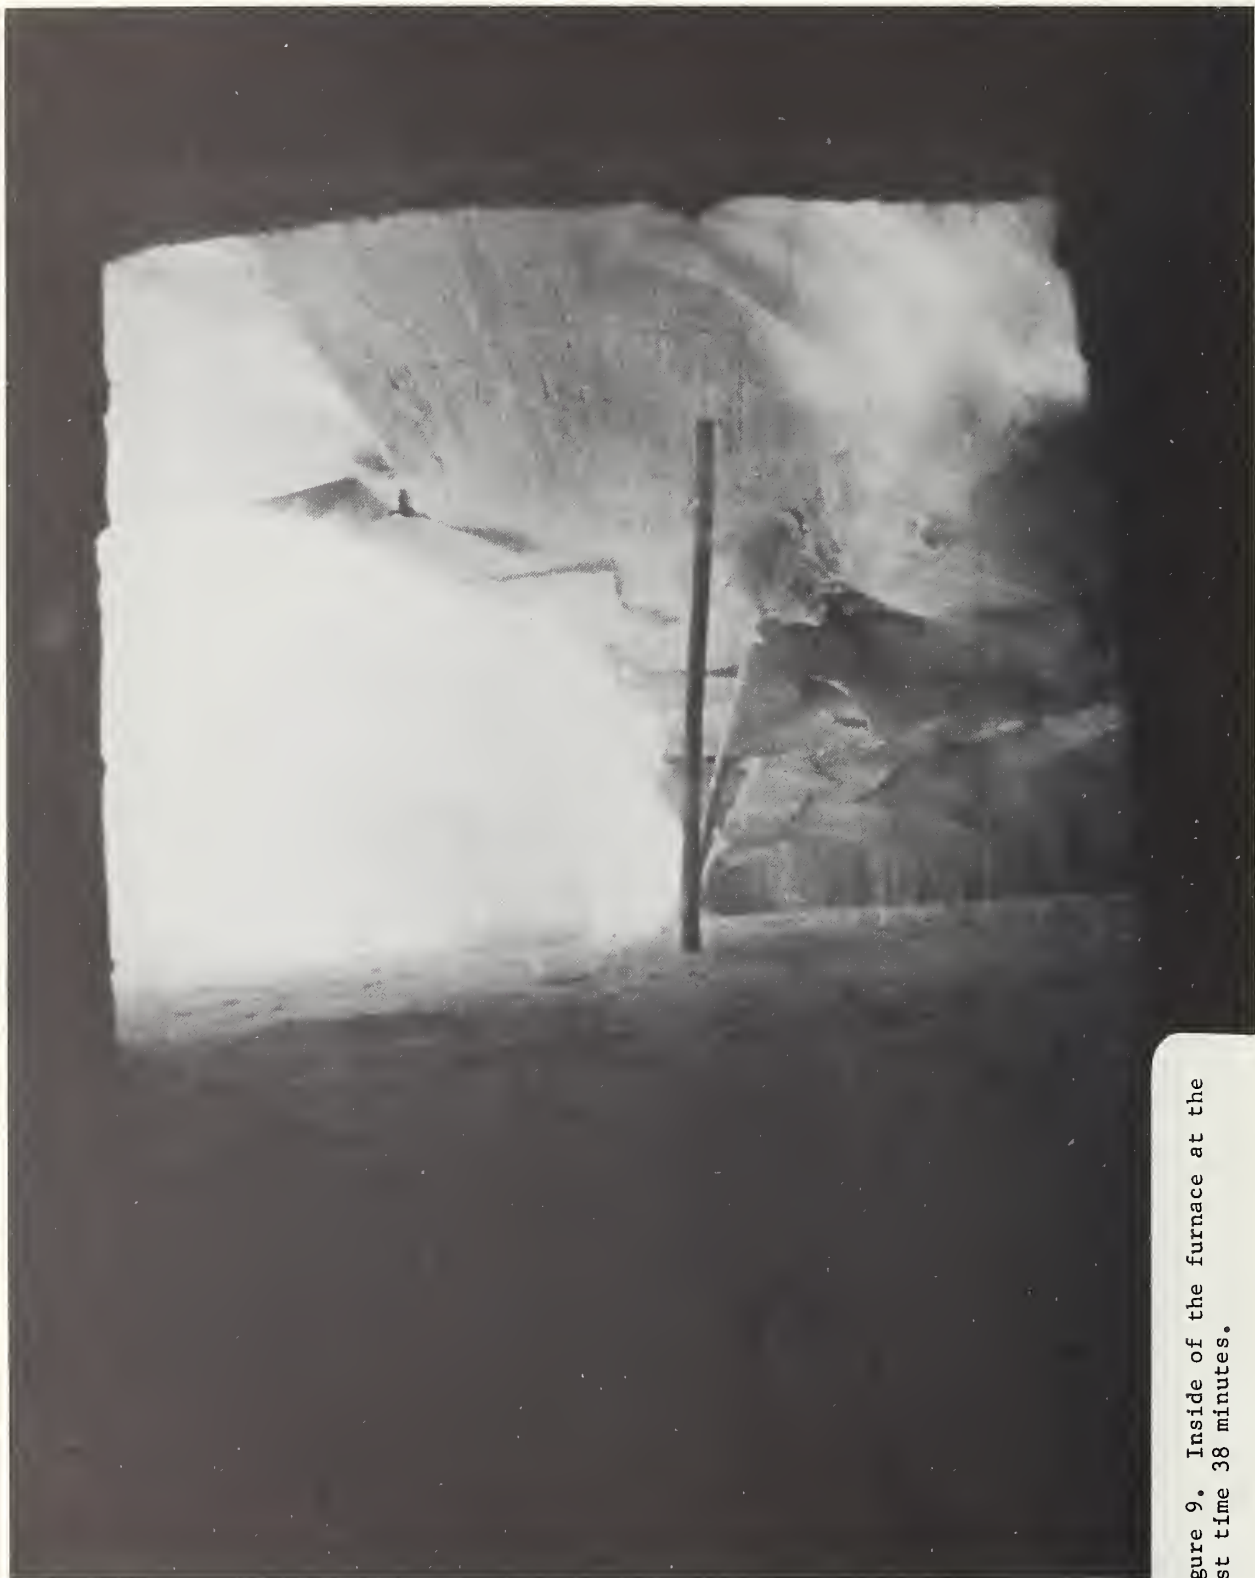
Figure 9. Inside of the furnace at the test time 38 minutes.

38:00	Collapse of 2/3 of the front face of the first wall. Figure 8 shows woven glass pieces hanging down on the ASTM furnace thermocouples and flaming from the hole in the face of the wall.

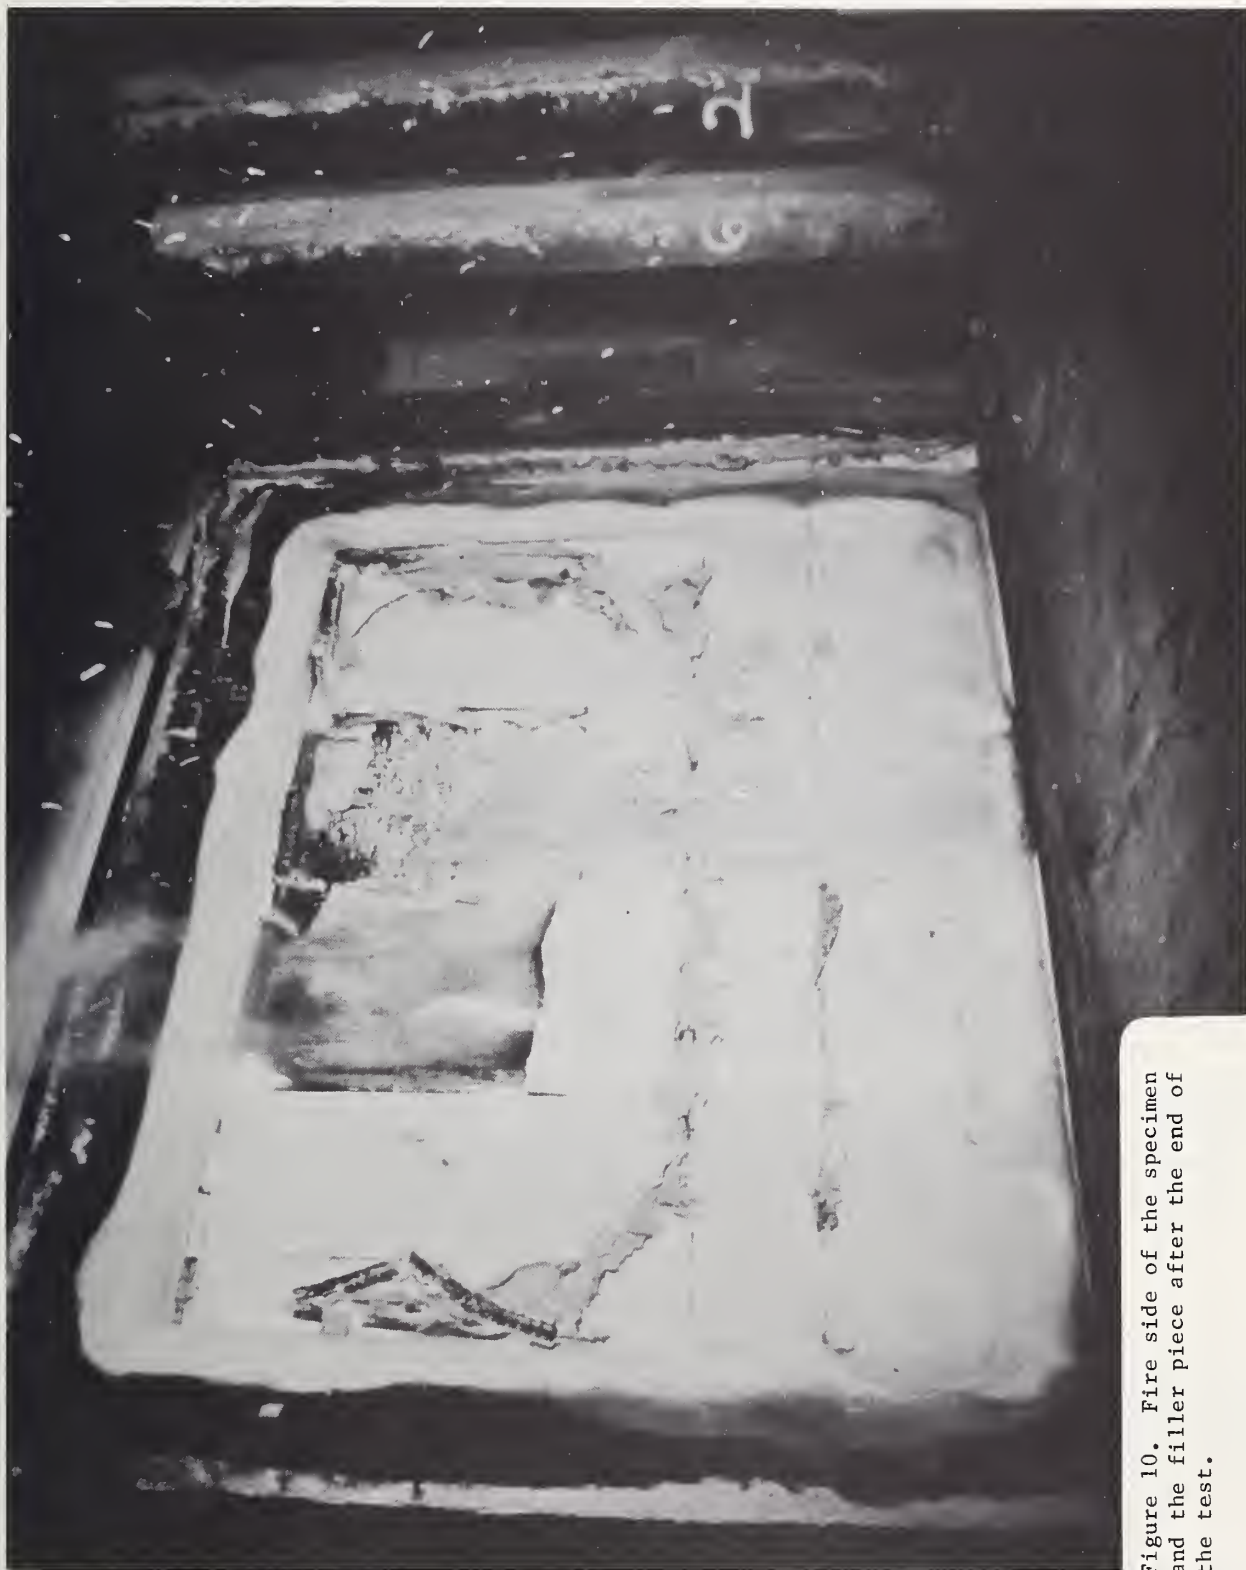
Figure 10. Fire side of the specimen and the filler piece after the end of the test.

93:40	Load Off. End of Test (Figure 9 shows the fire side of the wall assembly right after it was removed from the furnace.)
